SOUHEGAN RIVER WATERSHED
DAM NO. 28

NH 00429
NHWRB 147.26

PHASE I INSPECTION REPORT
NATIONAL DAM INSPECTION PROGRAM

AUGUST 1979

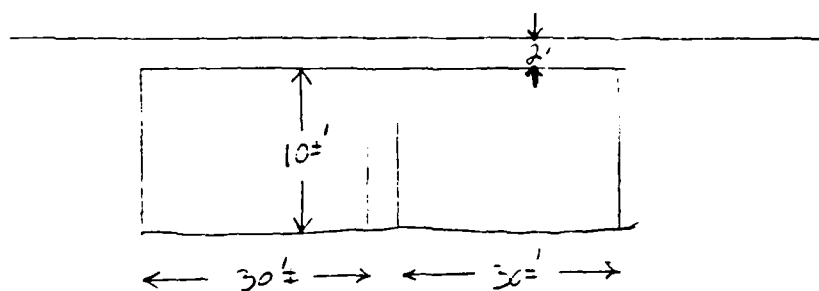
Railroad bridge 200' a/s of confluence

The estimated peak dam failure flow depth of 14' would probably damage the railroad bridge and roadbed.
